GRUMMAN AIRCRAFT ENGINEERING CORPORATION

LM ENGINEERING MEMO

LMO 541-108  
18 June 1968

DETAIL DATA EVALUATION REPORT, LM-3 OCP 61018, RUN  
BETWEEN 11 MAY AND 13 MAY 1968

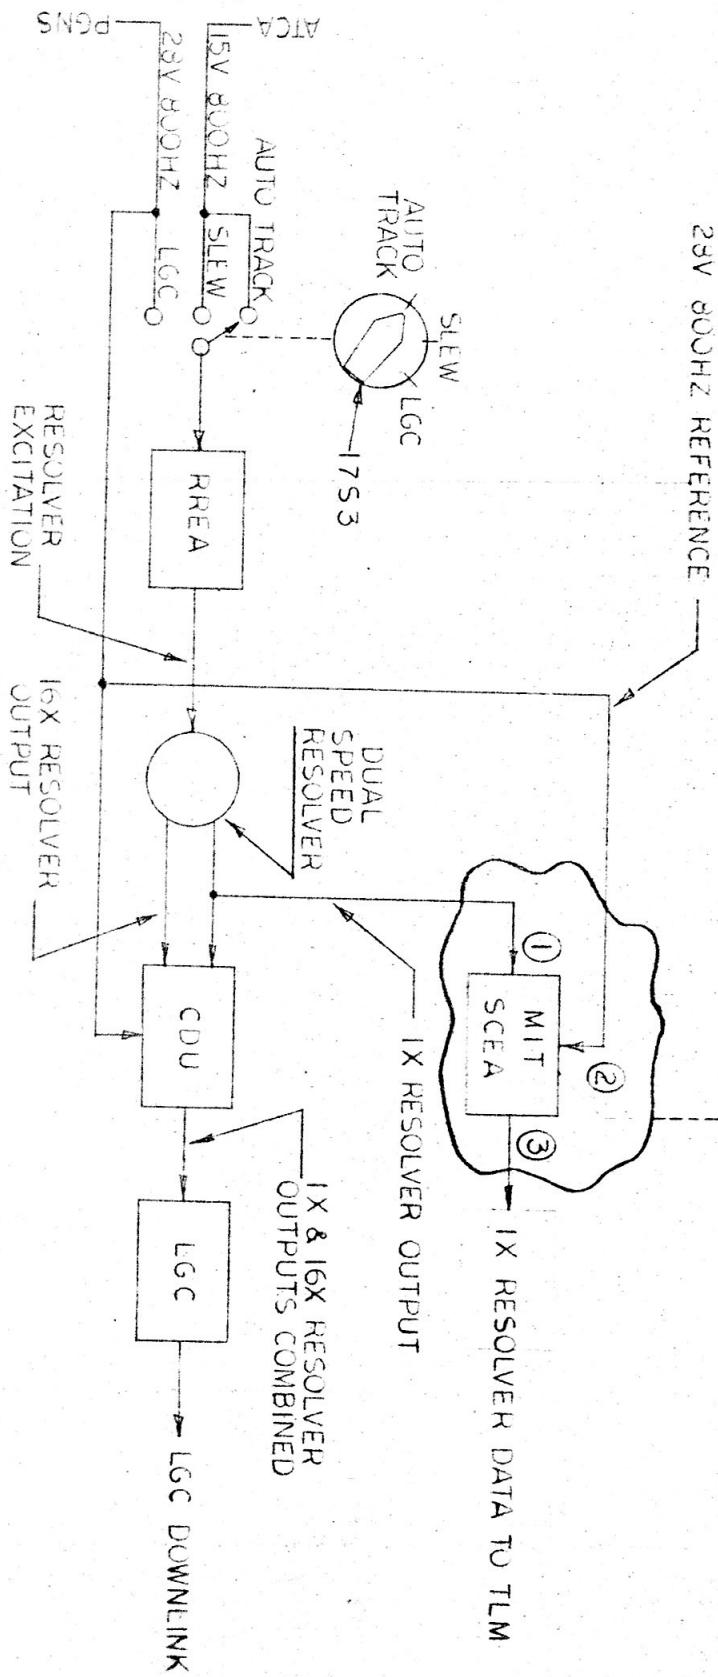
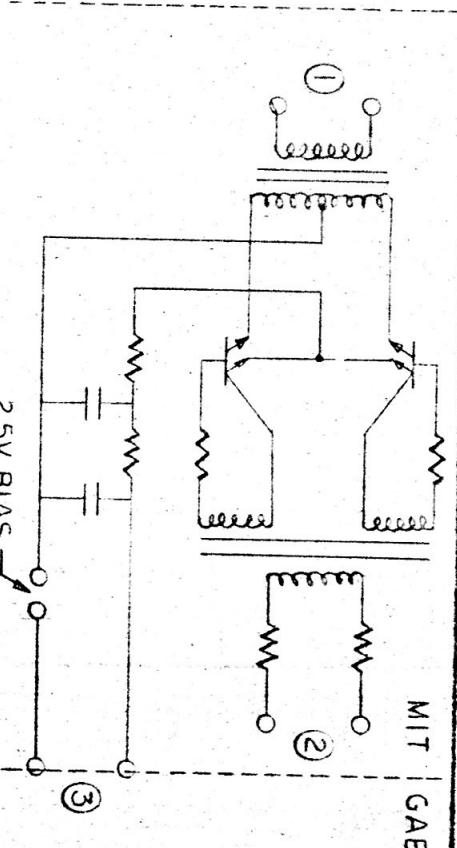
# RENDEZVOUS RADAR RESOLVER SIGNAL FLOW

The slew rates in the Manual Slew Mode were in error because of an incompatibility between the MIT Signal Conditioning Equipment and the ATCA 15V 800 Hz Resolver Excitation (See Enclosure 2). The PGNS and ATCA 800 Hz signals are not phase synchronized to each other, and hence a random phase difference exists between the resolver output and the demodulation reference signal in the MIT SCEA (Manual slew mode). In the LGC mode the MIT/SCEA and the Resolvers references are from the same supply, precluding an incompatibility. Consequently, the IX Resolver data is only meaningful with 17-S-3 in the LGC position.
